The Journey of the Lunar Flashlight Propulsion System from Launch through End of Mission

ABSTRACT

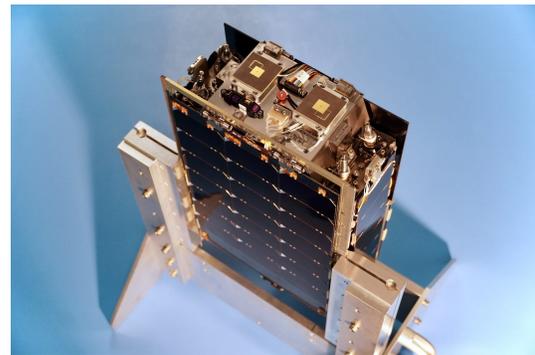
Figure 1: Integrated Lunar Flashlight Propulsion System Prior to Launch

The novel propulsion system (Figure 1), developed by GT and MSFC, was expected to perform the mission trajectory correction maneuvers (TCMs), Lunar orbit insertion, and momentum management burns. The attitude control system (ACS) for

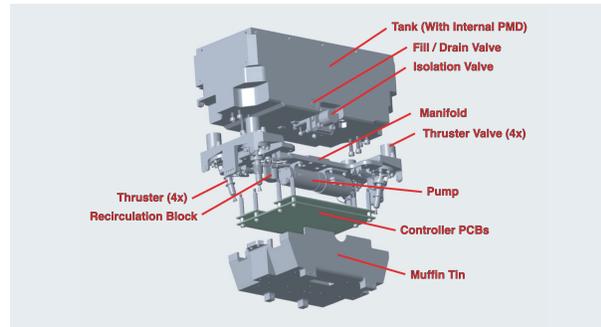
Figure 2: Expanded View of the LFPS

The LFPS is composed of two primary subassemblies, namely the propellant tank and manifold (Figure 2). The propellant tank subassembly includes a two-piece welded structure, as well as various components for propellant management and monitoring. These include a fill/drain valve for propellant loading, an isolation valve for isolating the tank from the manifold, a propellant management device (PMD)

for capturing the propellant in zero-g, a filter to restrict large particles from flowing out of the tank and into the manifold, a tank pressure sensor, and two Kapton heaters for maintaining required propellant temperatures. Additionally, the subassembly includes three thin and flexible thermocouples to monitor tank and heater temperatures.

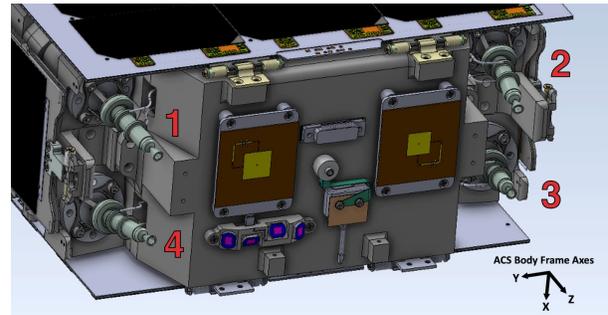
The LFPS uses four 100 mN thrusters located at the base of the spacecraft (Figure 3). All thrusters are mounted in the axial direction but canted inward allowing for delta-v capability and momentum management. It is a pump-fed system, using an electric gear pump to pressurize propellant to the operating pressure required by the thrusters. The propulsion components are mounted to a 3D-printed titanium distribution manifold, which also serves as a major structural component of the propulsion module.^{4,5}

Figure 3: Thruster Positions

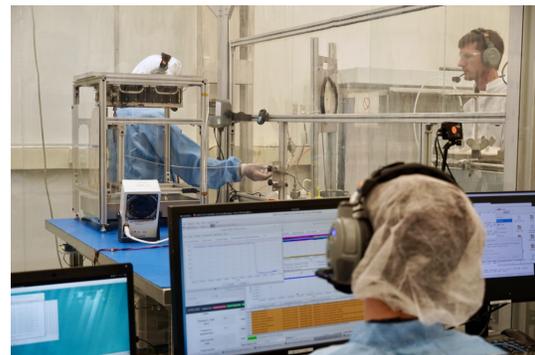
Figure 5: Propellant Loading Operation

Fueling and final SI&T activities took place at NASA MSFC. During the pre-fueling system functional test, the propulsion system's pump was briefly exercised to ensure the pump and motor driver functioned in their integrated state. During the fueling process (Figure 5), propellant was loaded into the tank through the fill/drain valve, followed by nitrogen pressurant. After performing final propulsion system and other system tests, the spacecraft was loaded into its dispenser for launch.

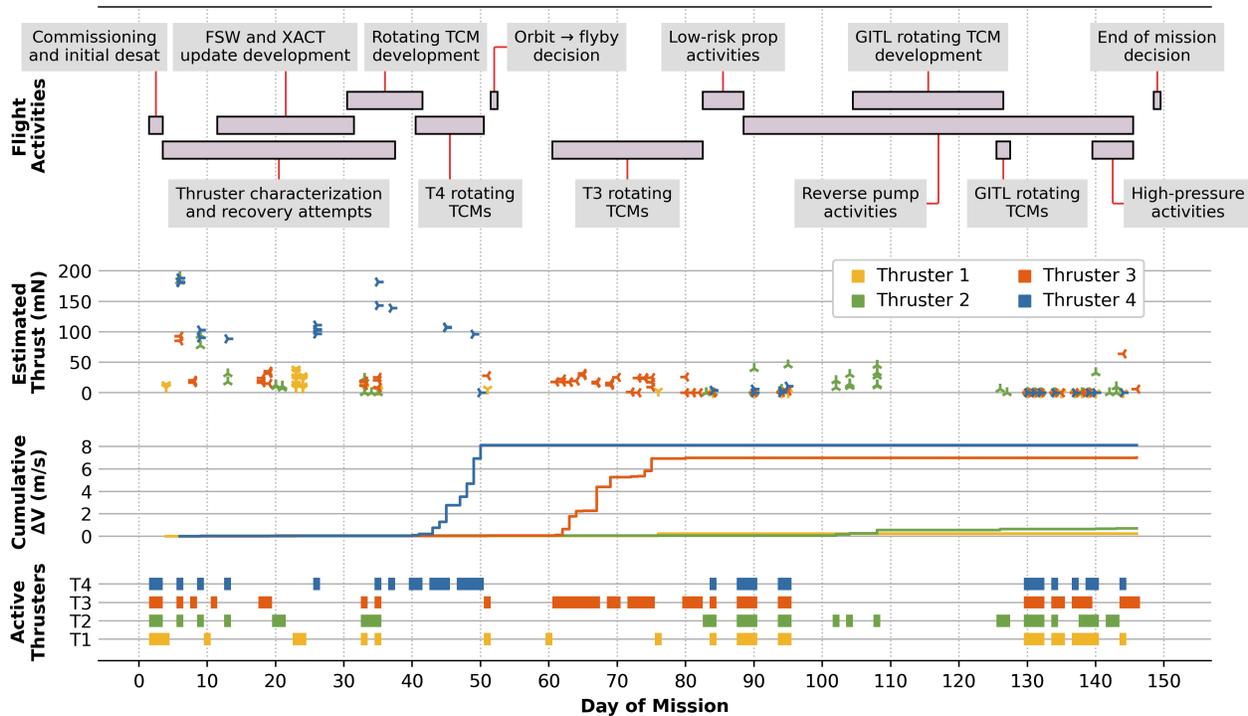
Figure 6: Lunar Flashlight Propulsion System Flight Activities and Performance*

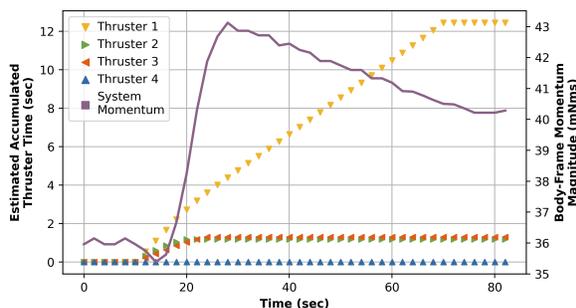
Following commissioning, the propulsion system was to perform the initial momentum desaturation maneuver, dumping momentum that the onboard reaction wheels were carrying from the initial de-tumble process. The thruster preheat process was performed, and the XACT was commanded to perform the desaturation maneuver. ACS telemetry and Doppler data indicated that thrust had been produced, but perplexingly, the system had entered a higher reaction wheel momentum state. A data review showed that the XACT had commanded thrusters 1, 2, and 3 to fire. The resultant change in angular momentum was consistent with thrusters 2 and 3 producing reasonable thrust, and thruster 1 producing a very small amount of thrust. Additionally, while thruster 2 and 3 were only commanded on for a few seconds at the start of the maneuver, the XACT continued to command thruster 1 to fire until the 60 second maneuver timeout was met (Figure 7). This indicated that thruster 1 was outputting a lower thrust level than expected by the attitude control system desaturation algorithm. An anomaly response team was assembled, which would later grow in size and scope as the team worked throughout the mission to develop methods of obtaining reliable thrust from the system.

Figure 7: Anomalous Desaturation Maneuver

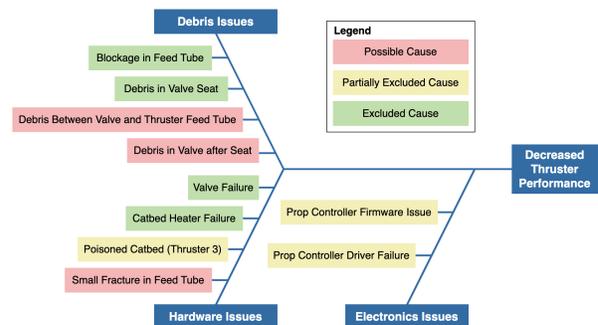
Figure 8: Initial Anomaly Fishbone Diagram

At this point, a fishbone diagram was laid out to track the possible issues on thrusters 1 and 3 (Figure 8). Foreign object debris (FOD) was considered the most likely culprit, but other possibilities were also considered. For example, simultaneous preheating of all four thrusters produced a notable drop in propulsion system voltage, so it was theorized that the voltage delivered to the valves might be too low. A test was performed which disabled thruster heating, then immediately fired the preheated thruster. This ensured sufficient voltage was reaching the valve, but there was no difference in the result.

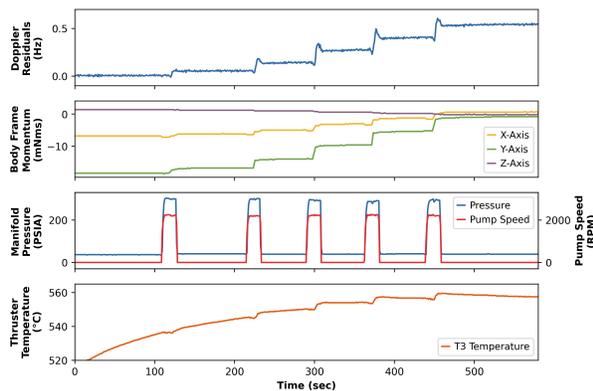
Figure 9: Doppler, Momentum, Temperature, and Pressure Response During a Successful Momentum Wheel Desaturation Activity[†]

During these initial recovery and characterization attempts, the Attitude Control System (ACS) and Mission Design and Navigation (MDNav) teams developed tooling to assist in understanding thruster performance. The ACS team utilized telemetered changes in spacecraft body momentum to calculate estimates of thruster performance, while the MDNav team looked at changes in Lunar Flashlight’s two-way Doppler signal. These two techniques allowed the propulsion team to quickly understand the results of thruster firings in real time. In addition to the estimates provided by ACS and MDNav, the propulsion team, or “prop” team, monitored the thermal response of each thruster as well as the manifold pressure response while firing to determine the health of each active thruster. As these monitoring and estimating techniques matured, the propulsion team gained the ability to make real-time decisions while performing flight tests. Figure 9 shows an example of the correlation between Doppler shift, momentum response, manifold pressure, and thruster temperature during a single-thruster momentum desaturation activity.

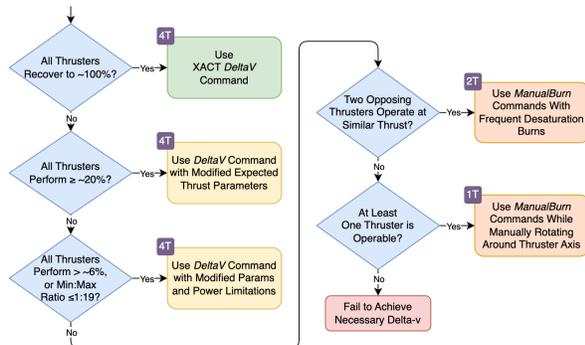
The original mission plans relied on the XACT to perform 4-thruster delta-v maneuvers with little operator intervention. Through a collaboration between MDNav, ACS, and BCT, it was determined that the XACT's *DeltaV* command could still be used in several scenarios, some requiring additional XACT parameter changes. First, if all thrusters recovered to near 100% performance, the project

could utilize the standard *DeltaV* command without adjustment. Second, if all thrusters recovered to above 20%, the XACT’s *DeltaV* mode could be used with modifications to its “expected thrust” parameters. Finally, if any thruster performance dropped below 20% but remained above 6%, additional timing and burn attitude limits would apply due to a likely lack of catalyst bed self-heating. Such a scenario would require constant preheating, placing additional strain on the system battery.

Figure 10: Trajectory Correction Maneuver Options Considered

Although recovery attempts were underway with the new momentum safety net and parameter updates, no appreciable amount of delta-v had yet been generated in-flight – only small momentum management burns had been performed. While these attempts continued, a set of options was developed to document the ways in which trajectory correction maneuvers might be successfully performed, allowing LF to enter orbit around the Moon (Figure 10).

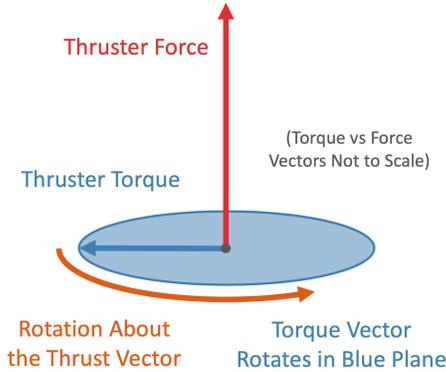
Development of the rotating TCM technique began with the assumption that the healthy thruster 4 would be utilized for single-thruster maneuvers, although the approach could be generalized to utilize any performant thruster. An important property of the technique was its ability to limit momentum build-up occurring from the thruster’s position on the spacecraft. The primary issue with firing one thruster was that it would impart a torque on the spacecraft, since no thruster’s force vector was aligned with the spacecraft’s center of mass. By rotating at a constant rate around the force vector of the active thruster, momentum build-up occurring at a given angle θ would be mostly cancelled out when the spacecraft was at the opposite angle $\theta + 180^\circ$, assuming constant thrust (Figure 11).

Figure 11: Simplified Drawing of Thruster Torque in the Inertial Frame. As the Spacecraft Rotates, Little Net Torque is Produced⁸

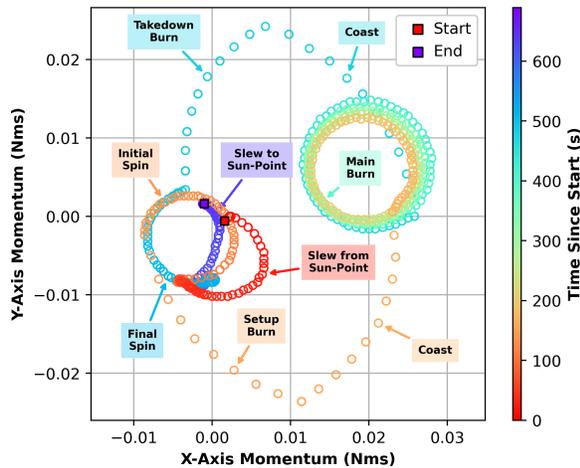
The x/y momentum plot in Figure 12 represents a close-to-ideal rotating trajectory correction maneuver. In it, the three burn phases (setup, main, and takedown) are clearly visible, with thruster 4 demonstrating fairly stable performance throughout the maneuver. The stable performance resulted in the final x/y momentum returning very close to the initial momentum. While the 15% duty cycle main burn lasted only 5 minutes, it resulted in approximately 0.51 m/s of delta-v. Telemetry from this maneuver can also be seen in Figure 13.

Figure 12: Spacecraft Body Frame X/Y Momentum Plot During Thruster 4 Rotating TCM #3

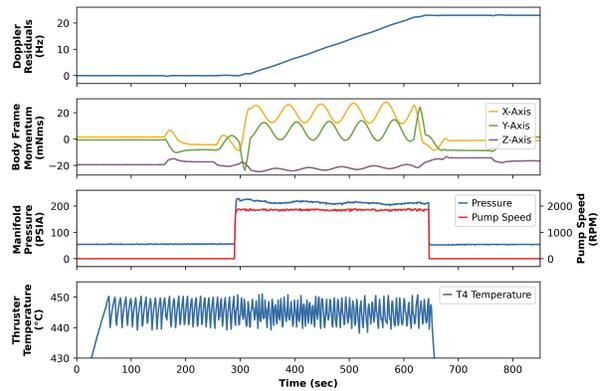
[‡]This is a prime example of a successful rotating TCM activity. Doppler and momentum indicate steady thrust. Thruster 4 rarely showed any signs of self-heating, even when producing nominal thrust, and this activity was no exception. The thermostatic control loop can be seen driving the temperature between 440°C to 450°C . A slight decrease in the thermostatic rise time could be indicative of small amounts of self-heating. During live rotating TCM activities, Doppler measurements showed a considerable sinusoidal component. This was due to antenna motion caused by the 1 RPM rotation of the spacecraft. The data used in this plot was post-processed to remove these antenna motion artifacts from the rotating TCM portion of the activity.

Figure 13: Thruster 4 Rotating TCM #3 (0.506 m/s of Delta-v)[‡]

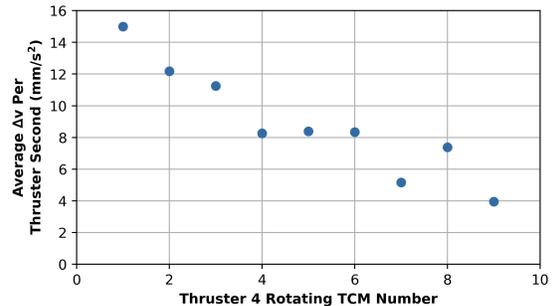
Figure 14: Thruster 4 Rotating TCMs: Average Delta-v Produced Per Thruster Second[§]

This pattern of rotating TCMs and desats continued for over a week. Figure 14 shows a downward trend of thruster performance over this period. Eight maneuvers were executed nominally, but

[§]“Thruster Seconds” are dependent on thruster duty cycle. For example, it would take 4 seconds of burning at 25% duty cycle to accumulate one thruster second.

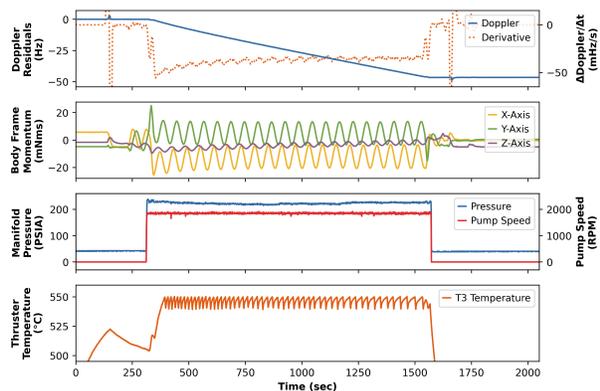
Figure 15: Thruster 3 Rotating TCM #8 (1.17 m/s of Delta-v)[¶]

[¶]Thrust remains steady throughout most of this rotating TCM, although there is some drift in momentum amplitude at the start of the maneuver, indicating a change in thrust. This is corroborated by the filtered derivative of the Doppler data. Self-heating of the thruster is apparent. A short drop-off in temperature at the beginning of the maneuver is due to the 60° delay between setup and main burns. Small disturbances in the Doppler measurements at the beginning and end of the activity are due to antenna motion, when the spacecraft slewed to the burn attitude, then back to sun-point. Although rotating TCM antenna motion was mostly processed out of this Doppler data, remnants are visible in the derivative.

Performance of the thruster 3 TCMs was highly varied. For example, during one 20-minute burn, thrust varied from 25 mN down to only 9.5 mN. This behavior may have been caused by FOD movement due to the motion of the propellant, pump, and thruster valve during the maneuver. Figure 15 shows an example of one of the steadier TCMs performed with thruster 3.

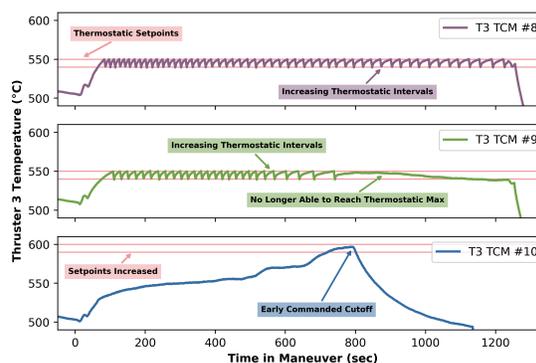
Self-heating behavior also differed widely. Initial maneuvers exhibited a steady moderate amount of thruster self-heating. Thruster temperature would drop as the spacecraft went off-sun, and this self-heating allowed the thruster to return to its thermostatic preheat setpoints once the burn began. However, over the course of several burns, this self-heating behavior became less and less effective, eventually being unable to maintain the preheat temperature (Figure 16). This signaled a lack of propellant reaching the thruster. The self-heating behavior then returned erratically, sometimes performing very closely to what was expected from ground testing, exceeding 800 °C.

Figure 16: Erratic Thruster 3 Thermal Responses

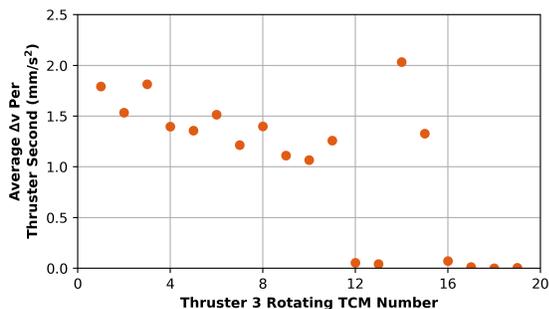
Initially, 11 TCM burns were executed successfully using thruster 3. This generated about 5.2 m/s of delta-v over 99.5 minutes of burn time. During these maneuvers, a general decrease in thrust was seen, corresponding to less delta-v per maneuver

(Figure 17). Raising the maneuver length to 20 minutes and duty cycle from 50% to 70% increased the delta-v produced in a given maneuver time, but the downward trend continued. Variability during maneuvers caused momentum build-up, even triggering the automated momentum safety net threshold response once. This behavior necessitated multiple momentum desaturation activities.

Figure 17: Thruster 3 Rotating TCMs: Average Delta-v Produced Per Thruster Second

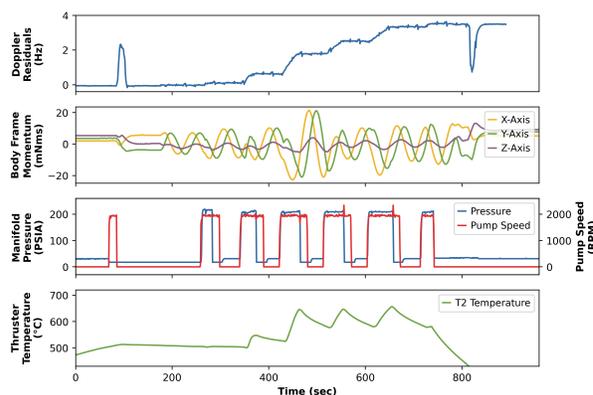
Figure 18: Rotating TCM with Pre-Timed Pump Reversals (0.09 m/s of Delta-v)[¶]

Overall, the improved performance indicated that with a system of properly-timed pump reversals, longer rotating TCMs might be possible once again. This was first tested with a rotating TCM command sequence using pre-timed reversals (Figure 18). After 20 seconds of forward-pump pulsing, the pump would “slam” to -2000 RPM for 15 sec-

onds. This cycle repeated throughout the maneuver with 20, 30, and 40-second burns. The 9-minute maneuver produced over 0.09 m/s of delta-v, but it was clear that the pre-timed reversals were negatively impacting performance, which varied from 20.2 mN down to 8.8 mN. Reversals would interrupt a period of good thrust, and once the next forward-pulsing period began, lower thrust was often seen. Two additional rotating maneuvers were performed with variations in timing, together producing about 0.19 m/s of delta-v, but it was apparent that the rigid timing of pre-compiled command sequences, with no branching logic, was not sufficient.

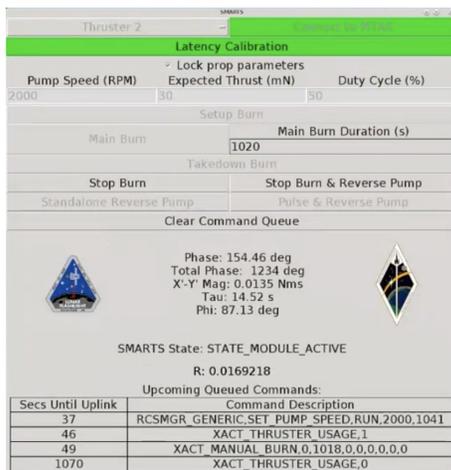
Figure 19: First Use of the Ground-In-The-Loop Tool to Perform a Rotating TCM

After the tool was developed and tested iteratively through a combination of testbed and in-flight activities, it was utilized to perform a GITL rotating TCM. Performance was initially strong, but thrust dropped towards zero over several minutes. Following the decision flowchart, operators performed a reverse pump operation, then restarted the main burn.

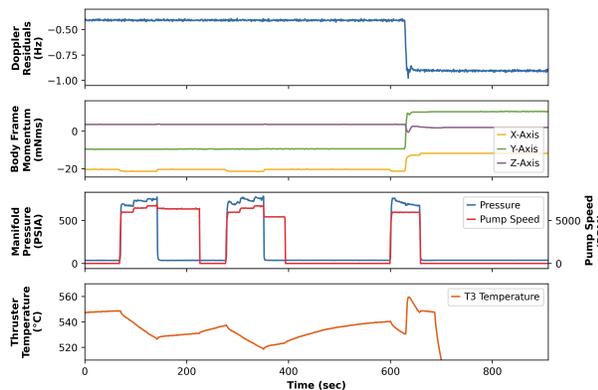
Figure 20: Thruster 3 High-Pressure Test (0.01 m/s of Delta-v)**

Another similar set of tests was run on thrusters 1, 3, and 4. Only thruster 3 had any response (Figure 20), so the test was repeated on thruster 3. First, a pulse train was attempted at 3000 RPM, resulting in no thrust. Following a pump reversal, the pump speed was raised to 5000 RPM, and a burn was attempted. This resulted in a rapid temperature drop,

**This data shows three high-pressure attempts at producing thrust. The last attempt shows a noticeable response in Doppler, momentum, and temperature. The first two attempts used a stair-step pattern to bring the pump speed from 6000 to 7000 RPM. Both times, the command from 6750 to 7000 RPM caused the magnetically coupled motor to become temporarily decoupled. For the third attempt, the pump was left at the initial 6000 RPM speed. Thruster temperature drops are visible whenever the pump was turned on. This was due to voltage drops from the high current draw of the pump, which caused less power to be available to the thruster heater. Small changes in the x-axis momentum plot correspond to pump activity. This is due to angular momentum stored in the spinning pump.

along with a drop in manifold pressure. The momentum and Doppler responses indicated a propulsive event, but it was not in the direction expected of a firing thruster, indicating that propellant had taken an abnormal path out of the system. It was surmised that thruster 3's feed tube had likely fractured as a result of the extremely high pressure and FOD.

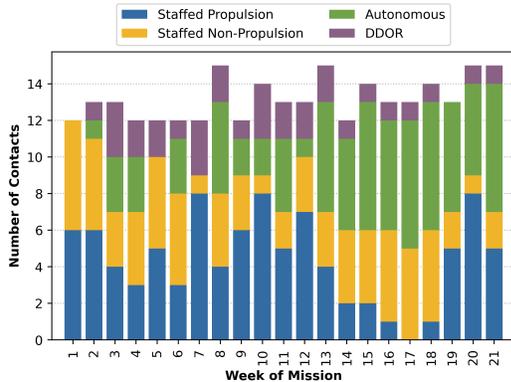
The level of effort required to operate this highly variable system had not been anticipated prior to launch. A review of mission data revealed that before the plans for a Lunar flyby were discontinued, 93 out of 166 staffed contacts included a propulsion system activity (Figure 21). This rate of prop-related activities was approximately five times higher than projected by the prelaunch concept of operations.

Figure 21: Contact Distribution by Week of Mission

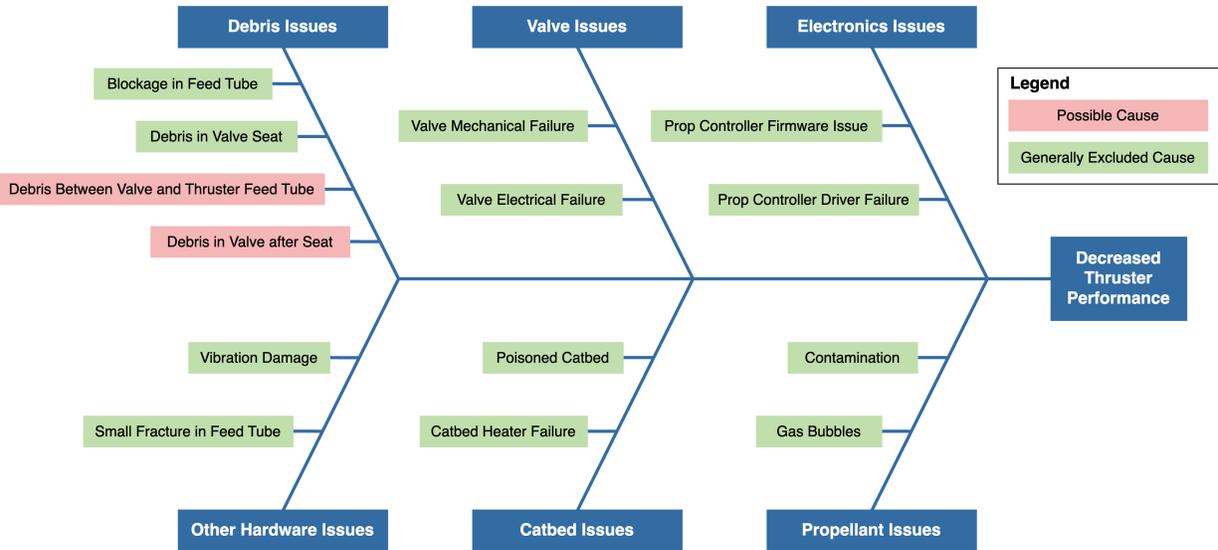
Figure 22: Final Low-Thrust Propulsion Anomaly Root Cause Analysis

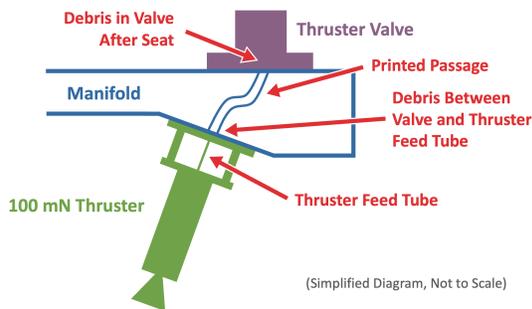
The source of the likely FOD was subject to some debate throughout the mission. Early on, one theory was that Krytox lubricant may have been introduced into the propellant flow path during integration of the valves and thrusters, as this had been experienced during ground testing. However, ground testing showed that this would likely have been flushed out or burned off over time. Another theory was that the additively manufactured manifold may not have been cleaned effectively. This was supported by cleanliness issues found with a spare manifold. Finally, it was theorized that particles originating from the printed manifold may have been dislodged by testing and launch vibration loads, as well as operational forces. Investigation of the manifold manufacturing and cleanliness processes led to a number of strong recommendations for future designs.

Figure 23: Likely Locations of Debris
