Lessons Learned in University Production of CubeSat Propulsion Systems

Mackenzie J. Glaser¹ and E. Glenn Lightsey²
Georgia Institute of Technology, Atlanta, Georgia, 30332

The Space Systems Design Lab (SSDL) at the Georgia Institute of Technology (GT) designs and manufactures propulsion systems for CubeSats using green monopropellant and cold gas propulsion technologies. Over the history of building these systems, a variety of off-nominal behaviors and nonconformances have been observed including contamination by foreign object debris, higher than acceptable leak rates, and inconsistent performance. Root cause investigations have been conducted where appropriate for individual systems and the identified root causes have included manufacturing defects, incomplete cleaning processes, and improper parts sizing. This paper collects and identifies historic off-nominal behaviors and nonconformances observed in SSDL-built propulsion systems and discusses the investigations of the root causes of these behaviors. These root cause issues are outlined and compared to present suspected systemic issues in propulsion system production. Root cause issues on each unit are added up based on the l

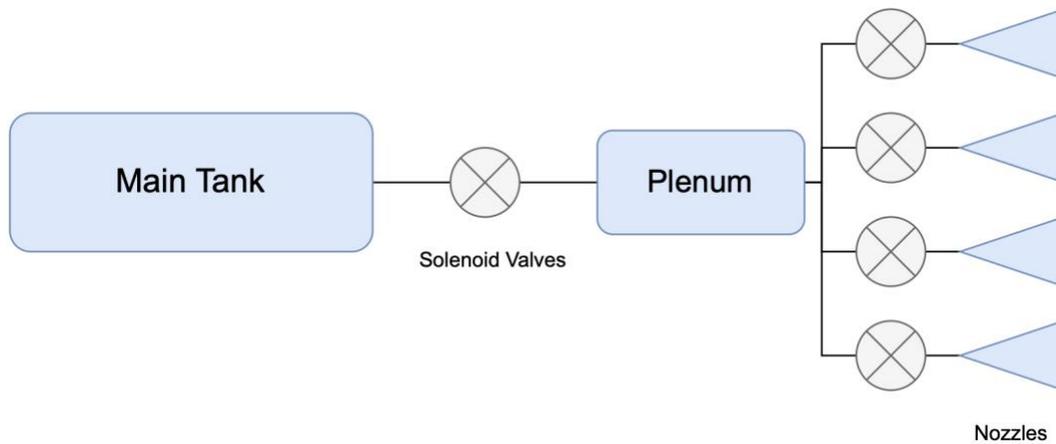
Figure 1. Cold Gas Propulsion Schematic

Cold gas propulsion systems are a relatively simple type of chemical propulsion. In the simplest versions, a tank of gas is attached to a valve and nozzle, and impulse is achieved by opening the valve to expel gas from the nozzle. SSDL-built cold gas systems are slightly more complicated because of their use of the propellant R-236fa, which is a refrigerant stored as a saturated liquid. This propellant was chosen for its high volumetric specific impulse, which is valuable in a volume-limited CubeSat application [1]. In these systems, the propellant is stored in the main tank as a saturated liquid, then is passed into the plenum to vaporize into a gas before being expelled out the nozzle, ensuring that only gas will be expelled. Figure 1 shows a schematic of a representative SSDL cold gas propulsion system.

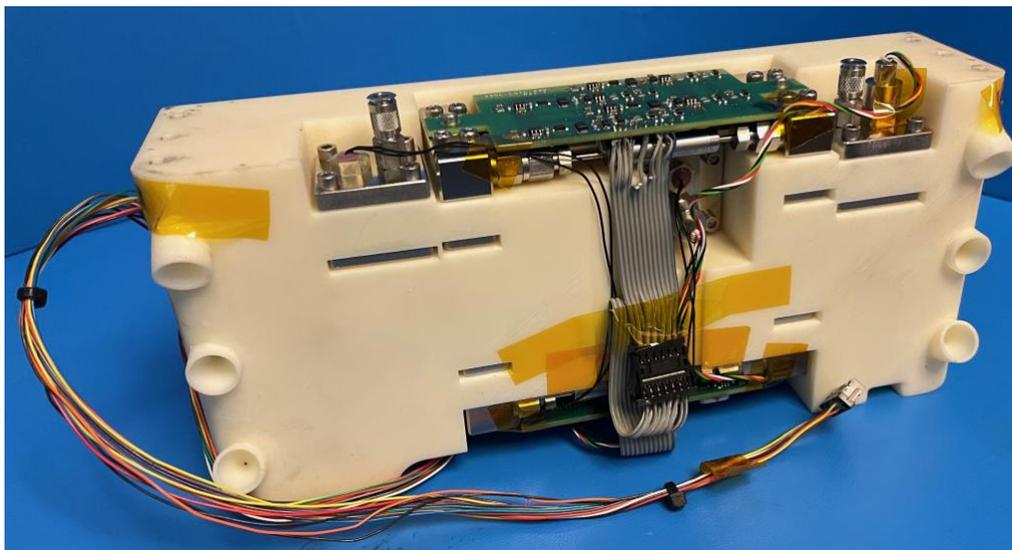
Figure 2. SunRISE Propulsion System

SSDL cold gas systems utilize a stereolithography (SLA) printing process with a resin called Somos Perform to manufacture the primary structure, and by doing so can include the main tank, the plenum, all routing between components, and the nozzles themselves as a part of one continuous piece. Utilizing additive manufacturing heavily also allows for the formation of complex geometry in the structures. Any available space on the satellite that could be occupied by the propulsion system can be utilized as a part of the tank volume, since these systems are not restricted to simplistic shapes. Once the structure has been printed, the components can be bolted into it, and the system is complete. Generally, pressure and temperature sensors are screwed into metal plates, and valves for each nozzle are assembled using metal blocks, then all the metal components are fixed to the structure [2]. Figure 2 shows the SunRISE propulsion system in its assembled state.

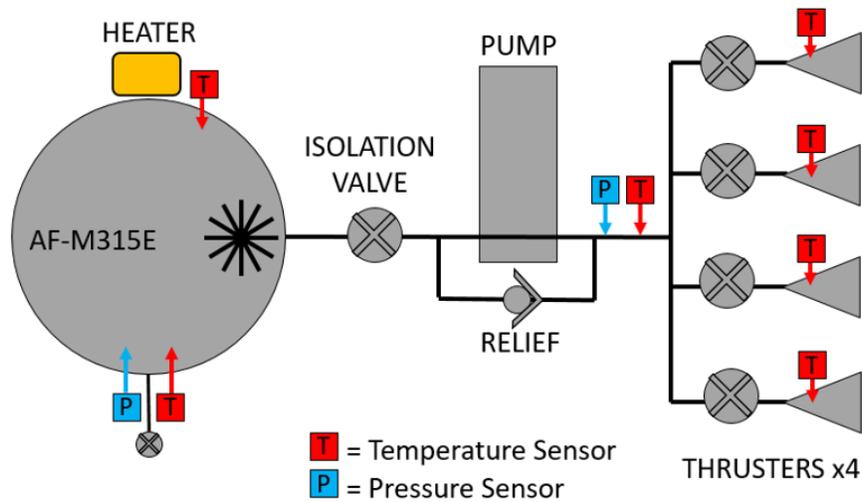
Figure 3. Lunar Flashlight Propulsion System Schematic [9]

Because of the constraints on use of the propellant, components were needed in the system that were different than the cold gas systems. Thrusters were procured for this system from a vendor called Plasma Processes; the thrusters have strict requirements on inlet pressure, so a pump with a recirculation loop for relief needed to be included in the system to provide the desired pressure. The inclusion of the pump allowed propellant in the tank to be stored below 100 psi, and thus not be characterized as fracture critical [9]. The schematic for the LFPS can be seen in Figure 3.

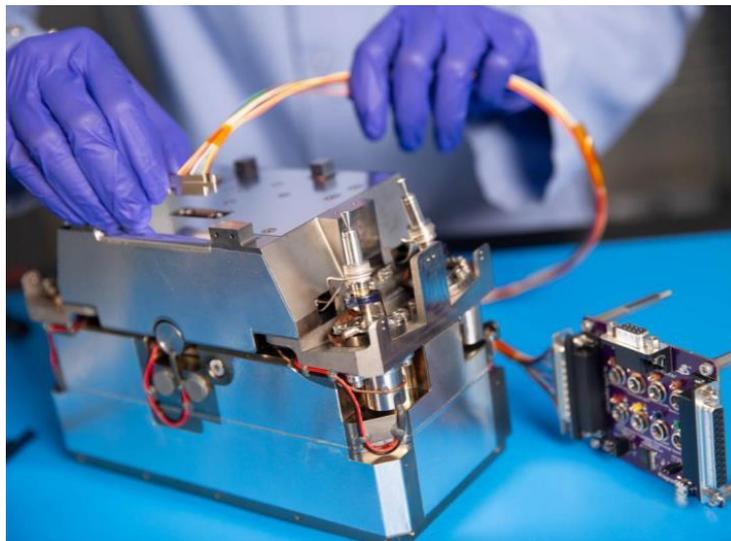
Figure 4. Lunar Flashlight Propulsion System

The LFPS was assembled over the course of 2020 and 2021. Through the assembly process, first the parts were procured, internal components to the tank were installed, and the tank halves were welded together. Then, components on the manifold like the valves and sensors were assembled to the manifold, components on the tank were assembled to the tank, and finally the tank and manifold were mated together. At each of these steps in the process, a pressure test was conducted to ensure the subassembly could meet its proof pressure, and there were no gross leaks. Then, the pump, controller boards, thrusters, and cover were installed, and the whole unit was tested as an assembled system [11]. The assembled LFPS is shown in Figure 4. The tank is the rectangular shape sitting on the table, and two of the four thrusters can be seen mounted on top of the manifold which is sitting on the tank.

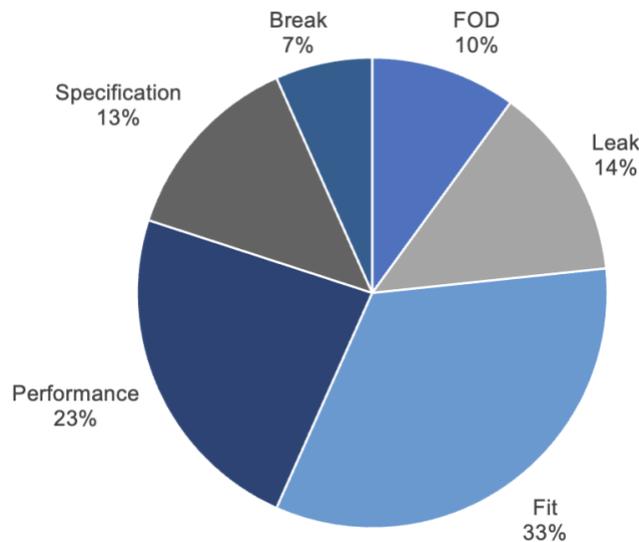
Figure 5. Nonconformance Categories

In this paper the approximately 30 nonconformances that have been documented on flight projects are examined. These nonconformances come mostly from the LFPS and SunRISE programs, as those programs have delivered hardware and had the most mature documentation requirements at the time of their assembly. These 30 nonconformances can be grouped by the basic issue observed into a few primary categories, as shown in Figure 5.

The categories can be described as follows. Fit nonconformances are those in which two or more designed parts fail to fit together properly, or a part is not properly sized for the interface it is supposed to meet. Performance nonconformances are those in testing or flight when the system is unable to meet its specified performance goals. Leak nonconformances are those when the pressure vessel is unable to hold a proper seal and propellant leaks out during testing. Specification nonconformances are somewhat unique – they are triggered when a system is unable to meet the requirement or tolerance specified, but the nonconformance is given a use-as-is disposition. These nonconformances

are generated as a result of a poor requirement on the system that it does not need to meet in order to complete its mission. FOD or foreign object debris nonconformances are ones where a precision cleaned part is visibly dirty: FOD can also be a cause of other categories nonconformances, but this category is specifically for the initial observation being FOD. Finally, a break nonconformance is one where a part has broken, typically seen during the assembly process.

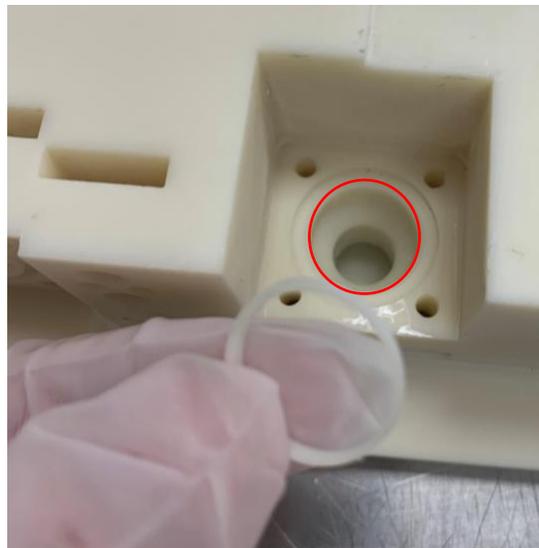
Figure 6. SunRISE O-Ring Nonconformance

SunRISE exhibited a significant fit nonconformance in the design of its O-Ring grooves. One of the systems had to be disassembled for rework after testing, and when it was disassembled, it was discovered that the inner wall of the O-Ring groove on the structure had failed and was no longer attached to the structure, as shown in Figure 6. The ring being held in the image is the O-Ring groove wall which should sit where the red circle is. This could cause an improper seal and could also contribute to FOD contaminating the tank. After investigating the failure of this part, it became obvious that the O-Ring groove was improperly sized for the O-Ring being used. It was close enough to appear correct when assembled, but the groove was too narrow which resulted in too much pressure being applied to the inner surface by the O-Ring causing it to break. For the already constructed units, the inner O-Ring grooves were machined off the structure, and the inner groove was instead added to the block which interfaces to that port – allowing the program to proceed without rebuilding the structures. An audit was conducted of other cold gas programs to ensure these design errors were corrected elsewhere, since they had been flowed down from a heritage design.

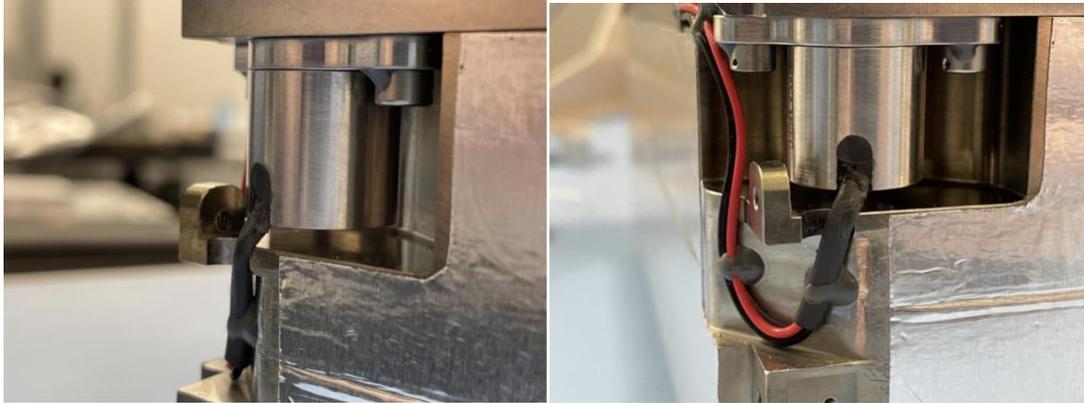
Figure 7. LFPS Wire Routing Defect Fix

Additionally, later in assembly an interference was discovered between the wire route and the corner of the tank that posed a risk to the wire. Because the wire route had not been carefully modeled in the original design process, this problem was not noted until actual assembly. The corner had to be drilled out and filed significantly to allow for the wire to route by it without any risk. To correct this problem going forward future systems should include wire routing from the initial design phase. The post-machining wire route is shown in Figure 7, and the circular cutout added to allow the wire to route as needed can be seen [12].

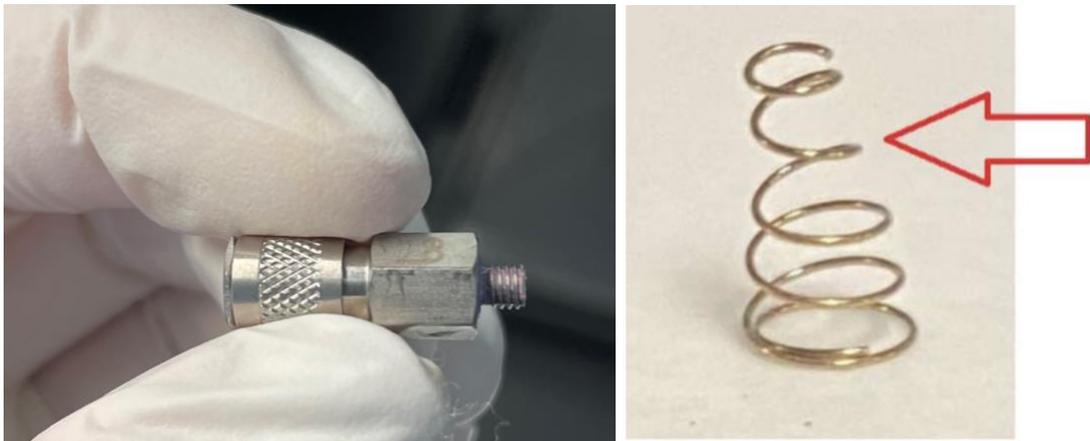
Figure 8. SunRISE Quick Disconnect Nonconformance

Performance nonconformances were one of the largest categories of nonconformance recorded throughout the program. The SunRISE propulsion systems have struggled with a range of performance nonconformances, starting from the first propellant fill of the first flight unit. The SunRISE units use the socket end of a quick-disconnect on the structure to allow a fill harness to be mated to the system for propellant fill. By design, when not mated to the other side quick disconnect, the quick disconnect connected to the unit will spring closed. When the flight unit was filled, and the fill harness was disconnected, the quick-disconnect stayed open, and allowed propellant to spray rapidly out of the system.

After numerous attempts to manually manipulate the quick disconnect into closing, the system was allowed to drain of propellant while the issue was investigated. Eventually, the system was disassembled to allow for a more thorough inspection and disassembly of the quick-disconnects themselves. Disassembly, inspection, and subsequent work with the vendor revealed that these parts had an internal spring that was made of a weak material and could be permanently deformed resulting in the quick-disconnects sticking open. The vendor has since updated the spring material for future units, and the SSDL programs which use this part have implemented testing campaigns to ensure every unit works correctly before it is installed into flight hardware. Figure 8 shows the poorly behaving quick-disconnect and the spring that contributed to its failure.

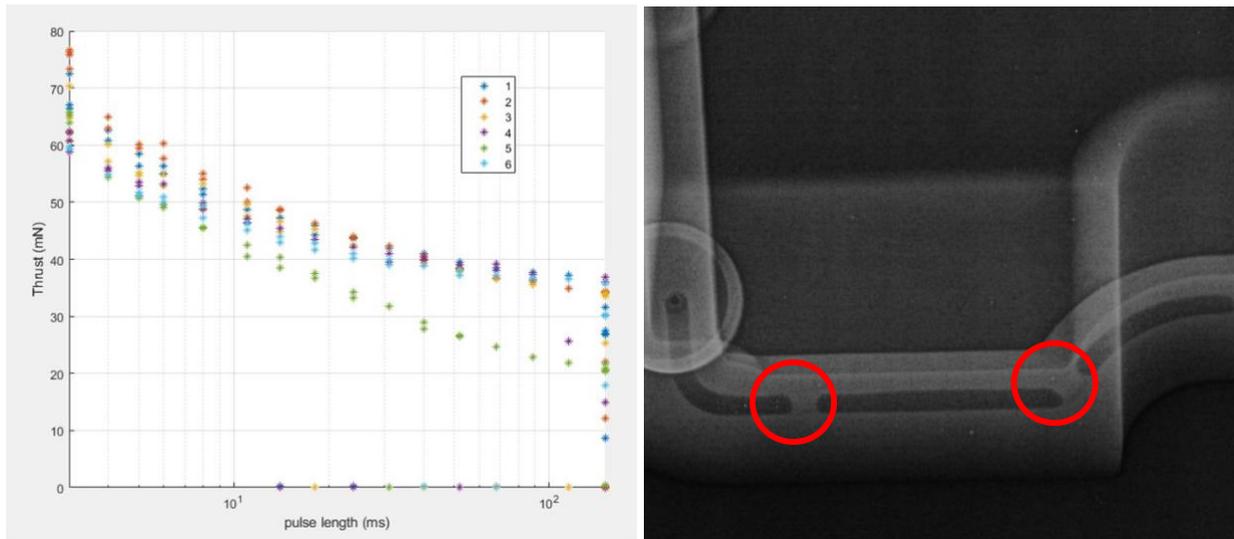
Figure 9. SunRISE Performance Data and Blocked Passage

Additionally, some SunRISE engineering development units (EDUs) had problems where during performance testing, one nozzle would significantly underperform the others as shown in Figure 9 with Nozzle 5. Inspection of the valves and electrical testing revealed the issue had to be a physical obstruction in the flow path attenuating the flow

to the nozzle. Several SunRISE EDUs were inspected and tested, and the problem was revealed to be twofold: first, the filters in the flowpaths had varying mass flow rates they would allow – some obstructed the flow significantly more than the others. Going forward, these filters were screened out of the flight parts with some testing prior to assembly. Secondly, some units had print defects leading to blocked passages.

These blocked passages occur in the printing process when the SLA resin is not adequately cleaned from the internal geometry before post-processing. The post-processing process the vendor completes includes a curing step, so if any resin is stuck in the part, it can be cured by the curing step, and remain stuck inside the structure: potentially attenuating flow or blocking a passage altogether. An example of a blocked passage can be seen in Figure 9. This image was taken with a CT scanner, and the blocked passages are circles in red. The solution to this problem is to adequately clean the print after the printing process but prior to the curing process. On SunRISE, the engineering team worked with the printing vendor to implement a rinsing process at their facility. Using syringes, the structure and internal channels were rinsed first with a cleaning agent and then with isopropyl alcohol prior to the cure, and this solution was able to prevent this problem on subsequent units.

For prevention of nonconformances in the additive manufacturing process, there should be clear communication to the vendor about the concern with material left behind prior to post processing and the risks it causes for the mission. When appropriate, SSDL should work with the vendor to design any GSE that may make the process of cleaning the interiors easier, or even send an engineer to observe the process and assist. The SunRISE program sent engineers to

the additive vendor used, and those engineers implemented a process of rinsing the internal geometry of the SunRISE units with a cleaning solution and isopropyl alcohol prior to post-processing the structures. Since the implementation of this process, no additional blocked-channel defects have been seen, this fix just required working closely with the shop over a matter of weeks.

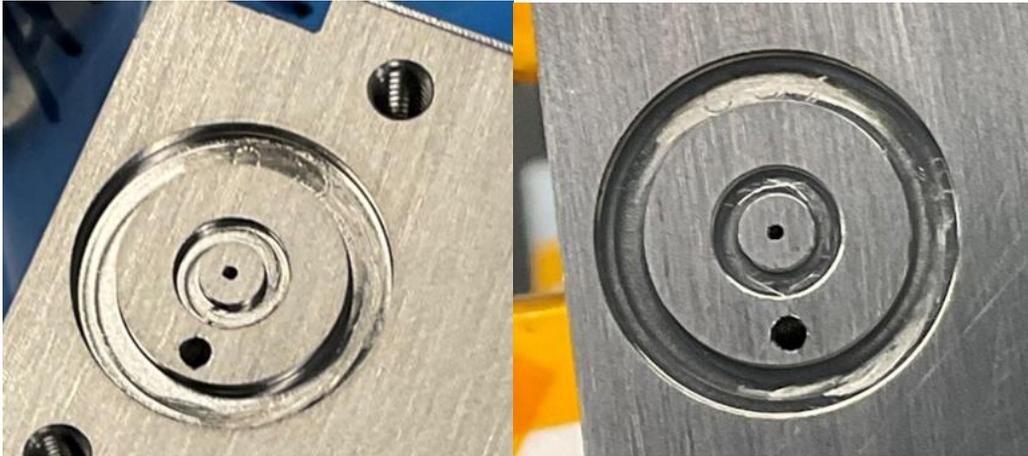
Figure 10. LFPS O-Ring Grooves with Scratches

One large leak was discovered on the LFPS SN002 system after that system was fully integrated and undergoing its leak rate check. Even when the valve was closed, helium was leaking past the valve, and exiting the system through the nozzle. The system was disassembled, and the structure was inspected to determine the cause of the leak. After a careful inspection, the team determined that there was a scratch in the O-Ring groove of the leaking valve, allowing fluid to entirely bypass the valve even when it was closed. This scratch was difficult to see on inspection, but could be felt with the use of a dental pick. After finding the scratch, the system was re-machined to put in a smoother groove. Similar small O-Ring groove scratches can be seen in Figure 10.

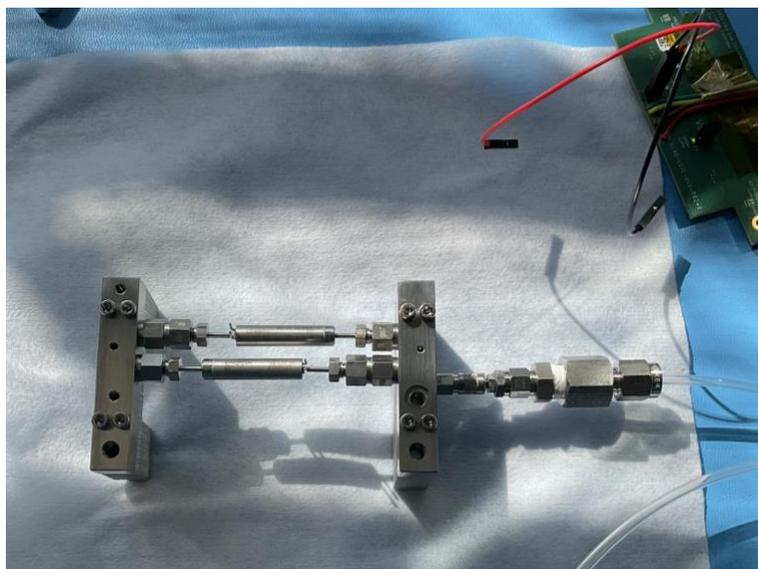
Figure 11. Manifold Swaging Leak-Check GSE

Leaks were also periodically seen on the cold gas programs, including BioSentinel, SunRISE, and SWARM-EX [13]. On these systems' EDUs, higher than expected leak rates were observed during vacuum chamber leak rate testing. Eventually, these leaks were identified to be coming from the interfaces of the valves with the fittings used to screw them into the systems. All used swage type fittings to interface to the structure, and the standard swaging process was not sufficient to seal these fittings against the valve stems. A process was implemented where after being swaged once, the valve manifolds were connected to a gas source, then checked for leaks at the swage joints using Snoop liquid leak detector. The sizes of the leaks at each of the sources were identified, and they were re-swaged until the leaks stopped. This process was able to bring the leak rates of these systems into tolerance, but going forward, the choice of fittings used on these systems may no longer be appropriate, given their standard leak rate. Figure 11 shows the process of leak-checking these manifolds to ensure that there are no leaks at the swage joints.

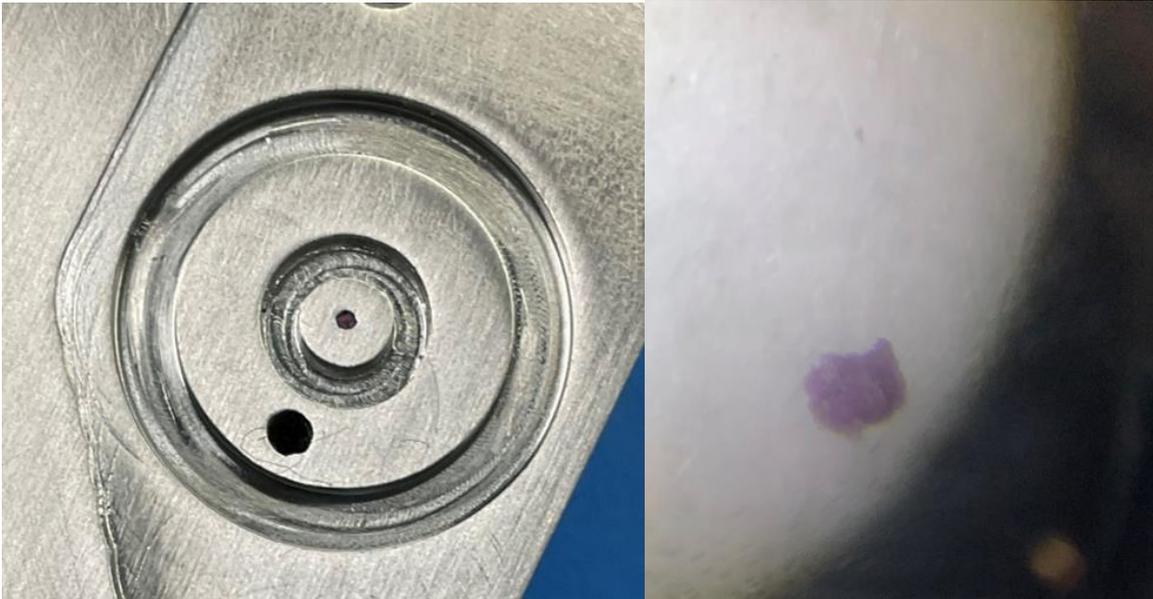
Figure 12. FOD in LFPS SN002 Manifold

Foreign object debris nonconformances are those where FOD is directly observed on a piece of precision cleaned hardware. One significant case of this was seen on the LFPS SN002 manifold. When the manifold was returned from the cleaning vendor after the O-Ring groove rework was complete, a piece of FOD was immediately spotted inside a flow path during inspection. What was seen during inspection, as well as some of the FOD after removal from the system is shown in Figure 12.

This FOD indicated that the manifold was not cleaned to specification by the cleaning vendor. The manifold was shipped to NASA MSFC to be re-cleaned, and the cleaning vendor will not be used on any future SSDL propulsion systems. It is important to note here that the LFPS flight unit and the SN002 unit were cleaned by the same vendor. Though the printing process may be at fault in the LFPS flight nonconformance, confidence in this vendor's ability to clean internal geometry is very low as a result of this FOD discovery (discovered after the launch of Lunar Flashlight).

Cleaning nonconformances are another of the most common manufacturing nonconformance types. The vendor previously used on certain programs is not reliable enough to continue to work with SSDL. Instead, a reliable vendor should be identified, and when parts are sent to them to be cleaned, SSDL engineers should work closely with the cleaning team to:

- 1) Define the necessary cleaning standard for the project
- 2) Communicate that internal geometry exists and is the most essential part to be cleaned
- 3) Determine a strategy and procedure for cleaning (and sampling) the internal geometry
 - a) Including an order of operations that is likely to result in clean internals
 - b) Including the development of any GSE needed to allow cleaning fluid to be flowed inside
- 4) Collect the data including the sampling numbers taken, and images and procedures of the interior structures being processed

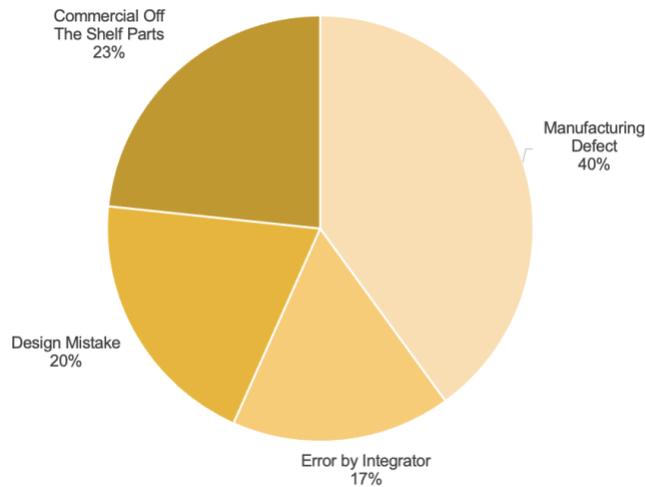
Figure 13. Nonconformance Root Causes

Identifying root causes is essential to the nonconformance process, and the examples included in Section IV discussed briefly the process of identifying the root causes of each issue, and the causes that were identified. All the nonconformances studied in this report, were grouped into four primary categories: COTS parts, manufacturing defects, design mistakes, and errors by integrator. These categories break down as shown in Figure 13.

Manufacturing defects make up the largest root cause category. Inside this category, the most prominent manufacturing defect is machining errors with problems like holes being drilled in the wrong place, improper surface finishes on parts, or burrs not being removed. Additionally, 25% of manufacturing defects were cleaning related defects meaning the part was sent to a cleaning vendor but not returned cleaned to specification. Finally, another significant portion were problems in additive manufacturing. Across both the cold gas and green monopropellant programs, additive manufacturing is heavily utilized to print SLA resin on cold gas and DMLS titanium on monopropellant. Though the methods are different, both share a similar issue: when the structures come off the print, if their internal geometry is not adequately cleaned before post-processing, it can result in blocked passageways, or the generation of FOD.

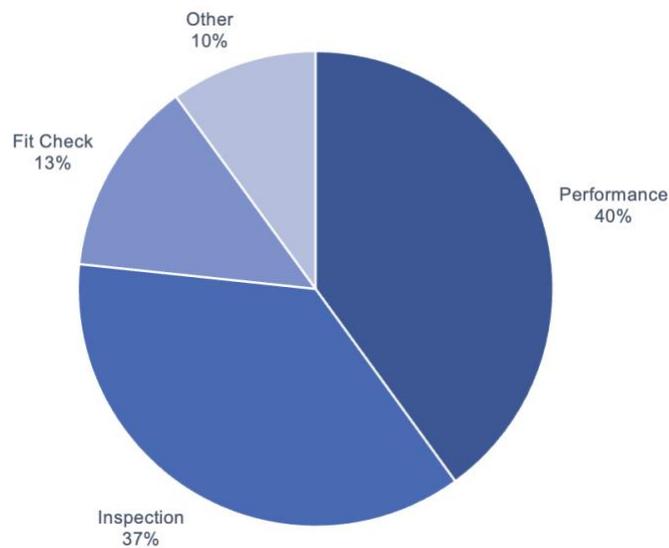
Figure 14. Nonconformance Identification Point

One critical area to understand in prevention of nonconformances is at what stage in the process of producing hardware those nonconformances are caught. Figure 14 illustrates the breakdown of where the documented nonconformances were caught. Based on the figure most nonconformances are caught either in performance (i.e. a bad test result or poor in-flight performance), or during an inspection of parts. Nonconformances being caught during inspection is the ideal scenario: generally, inspections are happening on individual parts, prior to time being spent assembling those parts. When problems are found, parts can go through additional fabrication steps to resolve the nonconformances without having to disassemble whole propulsion systems. When nonconformances are identified in performance, it is either because the system is already in flight (in which case it cannot be remedied), or because a problem was seen in testing. When it is a problem in testing, normally the unit must be at least partially disassembled to identify and correct an underlying issue. Thus, catching nonconformances during inspection significantly reduced time required to rework and correct a problem on a system.

Evaluation of the nonconformances that were identified downstream of inspection (either in fit check, performance, or elsewhere) found that approximately 37.5% of the nonconformances caught downstream of inspection could have been caught earlier with a more thorough inspection process. That makes up a significant portion which could be easier, quicker, and less costly to rework, if a more thorough inspection had been performed.

In order to prevent these inspection misses, a thorough inspection procedure should be written that includes inspection requirements for all hardware upon receiving. It should include sections conditional on the type of parts being inspected, including special inspection processes for:

- 1) Sealing surfaces like O-Ring grooves
- 2) Visual cleanliness, and cleanliness after swabbing
- 3) Threads of components
- 4) O-Ring surfaces
- 5) Machined part surface finish, sharp edges, and burrs
- 6) Additive part internal passages

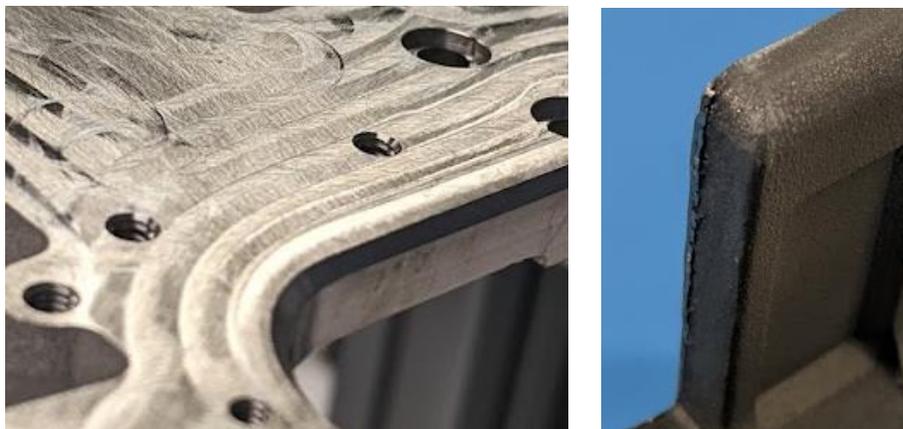
Figure 15. Poor Surface Finish and Burrs on LFPS Component

On drawings, particular attention should be paid to requirements around removing burrs and sharp edges, tolerancing of holes, and surface finishes. Without requirements applied to the drawing and communicated with the shop, these defects will not be removed, and parts may exhibit some of the traits seen in Figure 15.

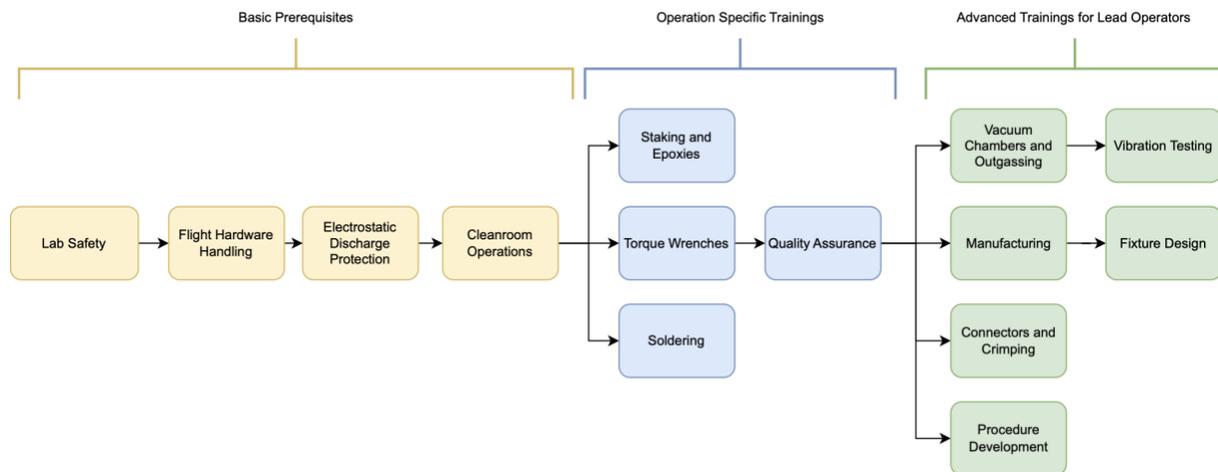
Figure 16. Hardware Training Flow Diagram

Operator process training has been significantly improved by the addition of a spacecraft engineering course dedicated to working with hardware. Key to this training program are: torque wrench training, electrostatic discharge protection training, cleanroom training, epoxy training, and general training on proper fixturing and handling of hardware (avoiding things like wire snags, and drops of tooling or hardware). A suggested flow of required training operations can be seen in Figure 16. Whether through this course or through the lab in general, all SSDL engineers who will be in contact with flight hardware must undergo these trainings to be able to lead flight hardware procedures, and this training should be given and verified by senior engineers in the group.
